Figure 10
Invasive Species Map

Trailhead Blue Springs, Levy County, FL
2023 Natural Color Orthophotos,
(0.5-m) resolution

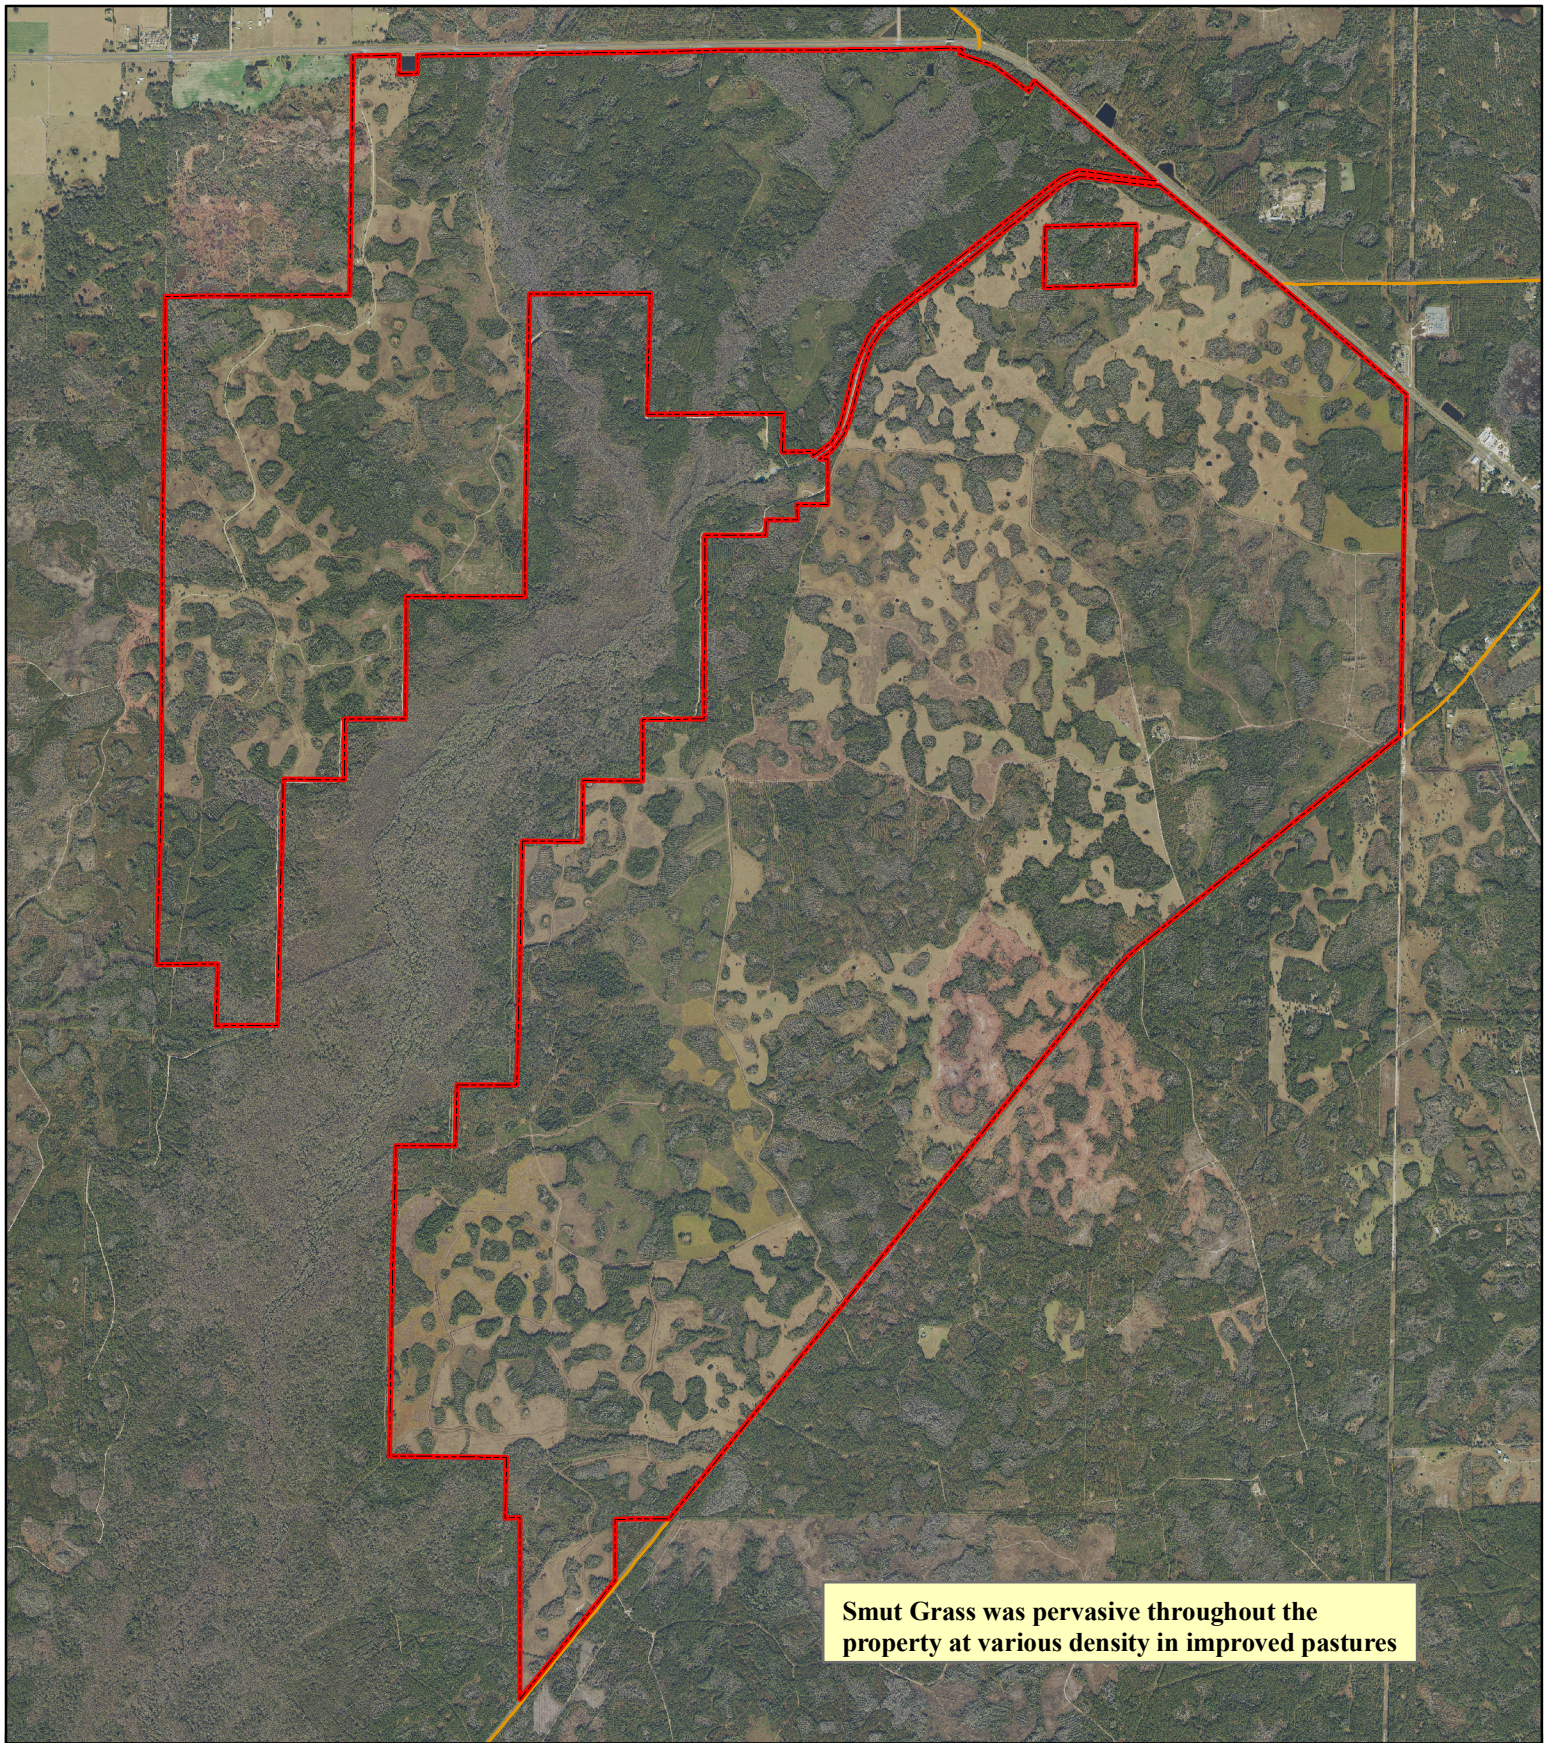
Smut Grass was pervasive throughout the property at various density in improved pastures
